## Road and Railroad Crossing Inventory

Little Coulee

U.S. Department of the Interior  
Bureau of Reclamation  
Great Plains Region  
Dakotas Area Office

September 2005

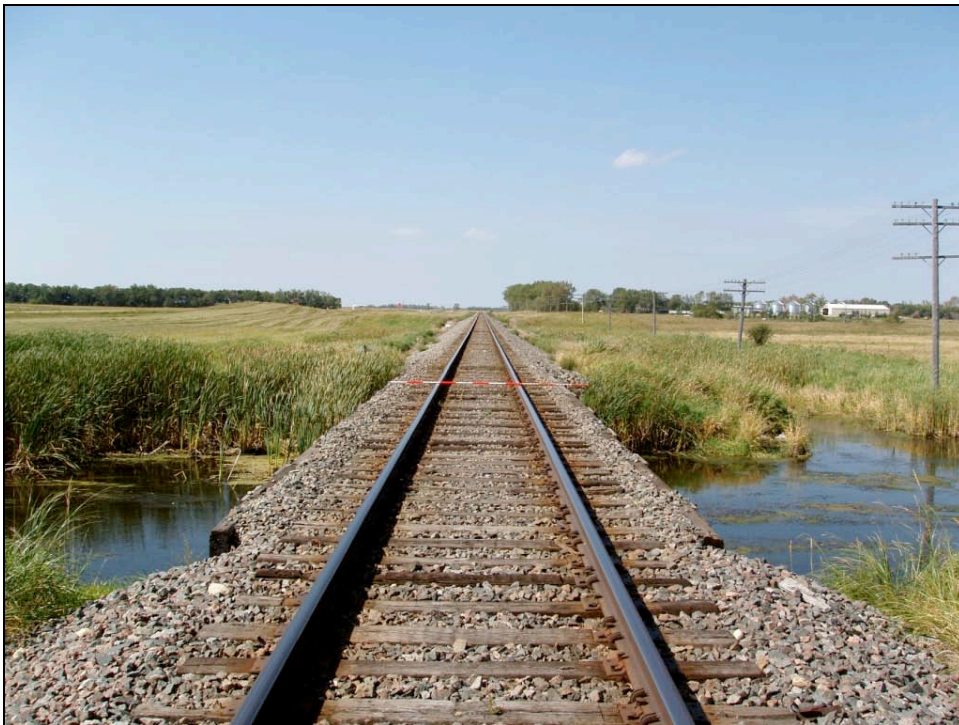
L12 Center of wood & concrete railroad bridge, looking west, in good condition, Section 36, T156N, R69W, N 473698.57, E 2253219.64, elevation 1487.3 @ C/L of bridge. top of railroad tie.

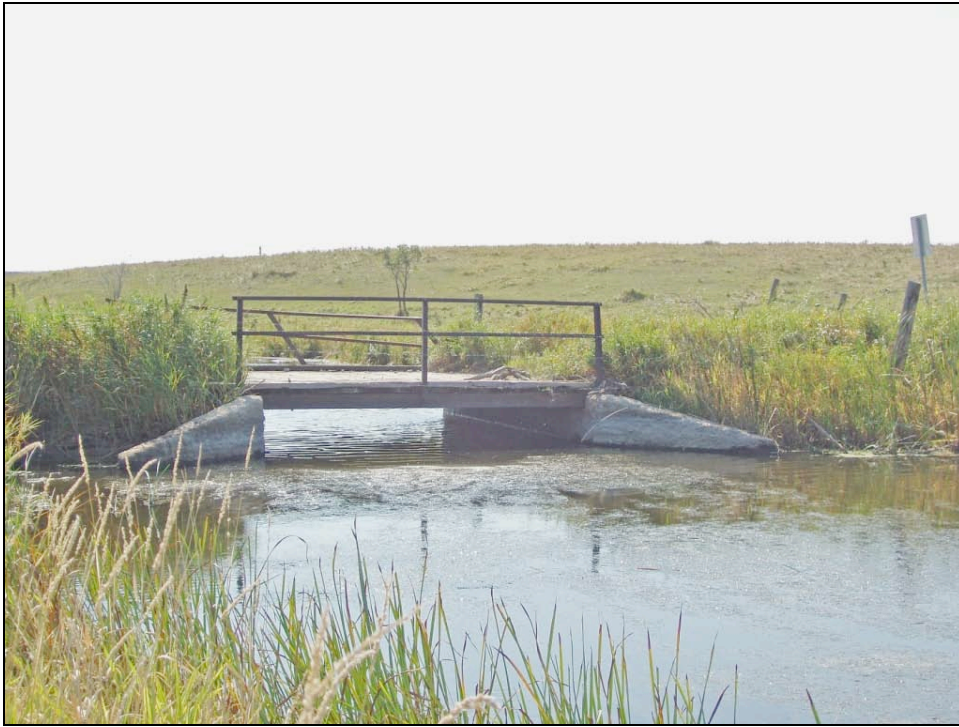
L13 Upstream side of wood,& concrete bridge, in fair condition, 4.7 feet of water (09-8-05), Section 25 & 36, T156N, R69W, N 474489.07, E 2252908.15, coulee bottom elevation 1475.3 @ C/L of bridge.

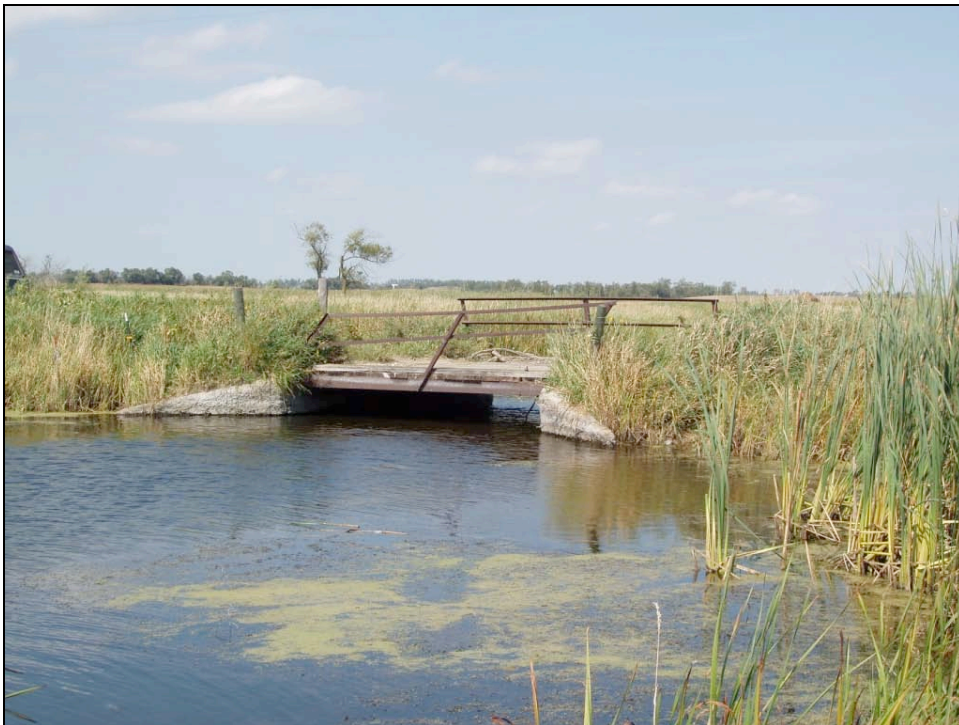
L13 Downstream side of wood & concrete bridge, in fair condition, 4.2 feet of water (09-8-05), Section 25 & 36, T156N, R69W, N 474470.76, E 2252908.66, coulee bottom elevation 1475.8 @ C/L of bridge.

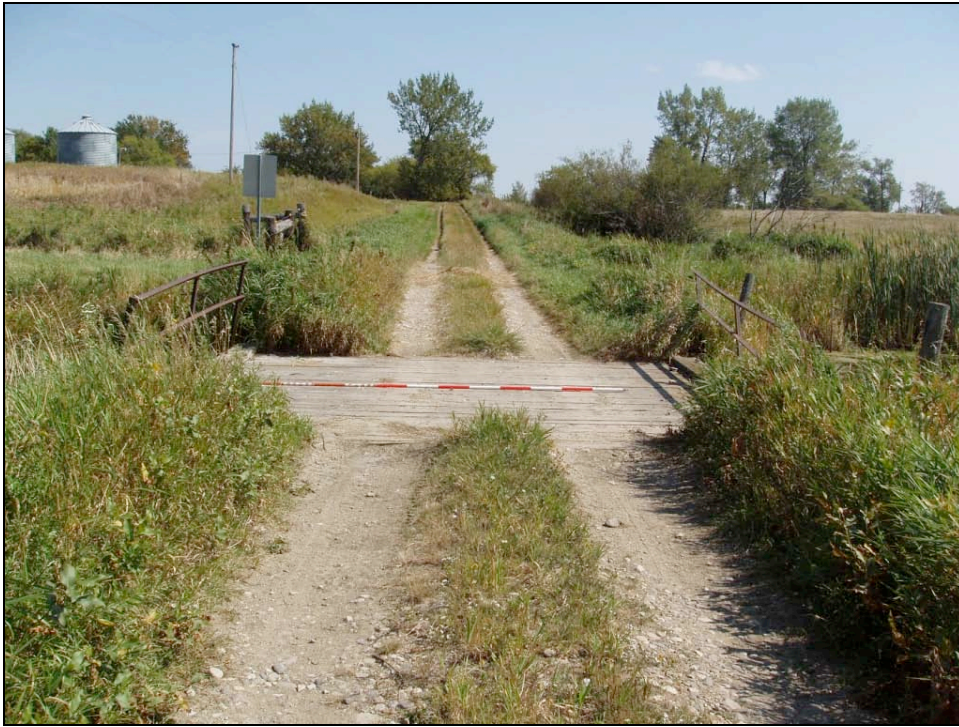
L13 Center of wood, & concrete bridge, looking east, in fair condition, 18.0 feet wide & 15.2 feet wide, Section 25 & 36, T156N, R69W, N 474479.54, E 2252907.74, elevation 1482.4 @ C/L of bridge, top of wood.

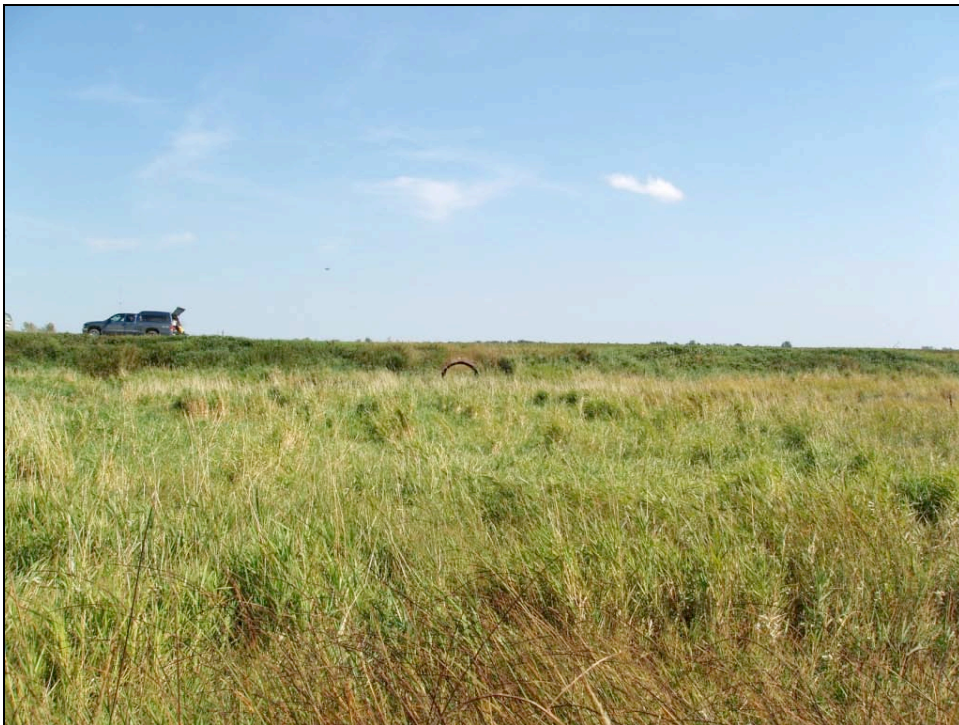
L14 Upstream side of three CMPs (48", 72", & 48") in good condition, no water, 0.3 feet & 1.4 feet of water (09-8-05), from south to north, Section 23 & 24, T156N,R69W, N 481052.30, E 2248026.72, elevation 1495.3 @ invert of 48" CMP, N 481134.37, E 2248021.60, elevation 1494.3 @ invert of 72" CMP, N 481190.90, E 2248031.13, elevation 1492.4 @ invert of 48" CMP.

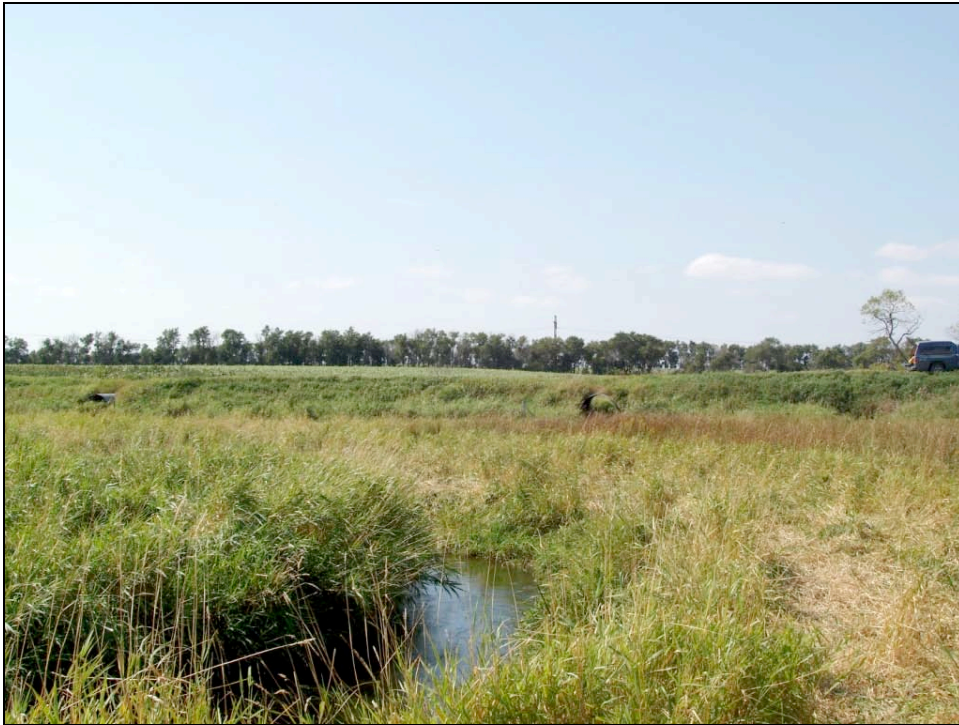
L14 Downstream side of three CMPs (48", 72", & 48") in good condition, no water, 0.3 feet & 1.0 feet of water (09-8-05), from south to north, Section 23 & 24, T156N, R69W, N 481053.55, E 2248076.78, elevation 1495.1 @ invert of 48" CMP, N 481137.91, E 2248081.93, elevation 1493.6 @ invert of 72" CMP, N 481180.48, E 2248074.72, elevation 1492.3 @ invert of 48" CMP.

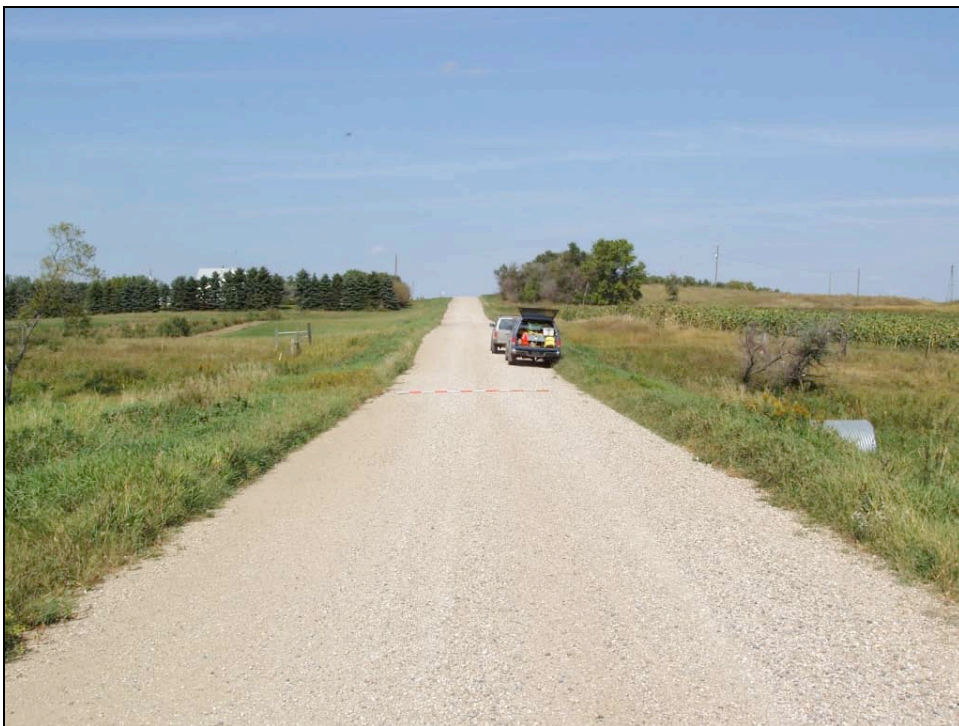
L14 Center of road crossing, across three CMPs, looking north, Section 23 & 24, T156N, R69W, N 481137.35, E 2248050.57, elevation 1501.9 @ center of road crossing, top of gravel.

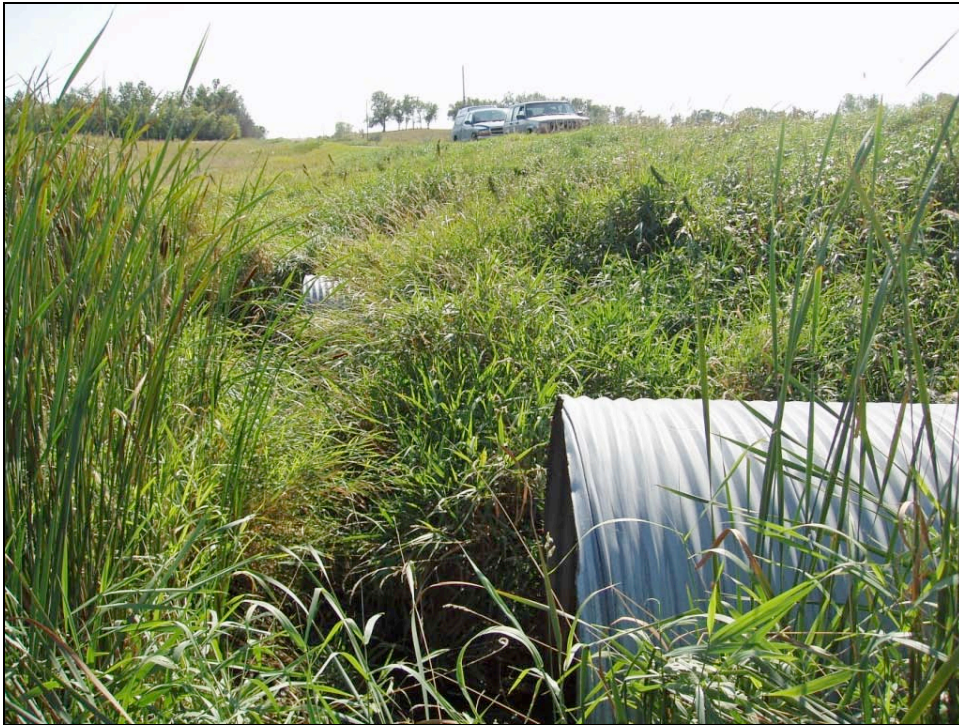
L15 Upstream side of two CMPs (48" & 60") in good condition, 0.6 feet, & 1.4 feet of water (09-8-05), from south to north, Section 23 & 24, T156N, R69W, N 483084.58, E 2248049.26, elevation 1499.8 @ invert of 48" CMP, N 483111.37, E 2248047.46, elevation 1499.0 @ invert of 60" CMP.

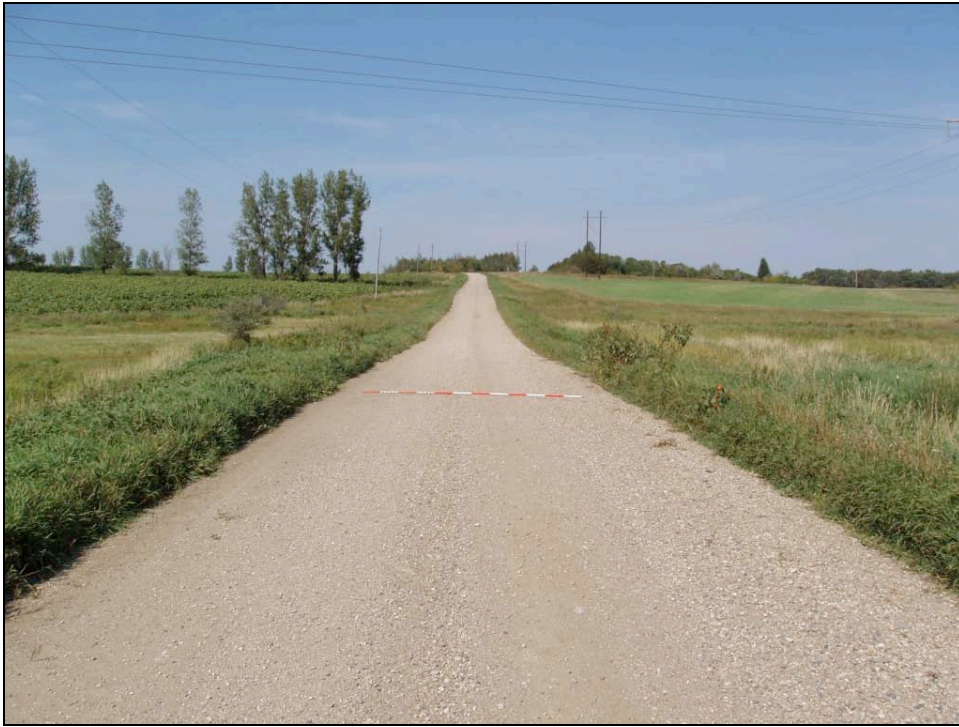
L15 Center of road, across two CMPs, looking north, Section 23 & 24, T156N, R9W, N 483095.32, E 2248018.43, elevation 1508.5 @ center of road crossing, top of gravel.

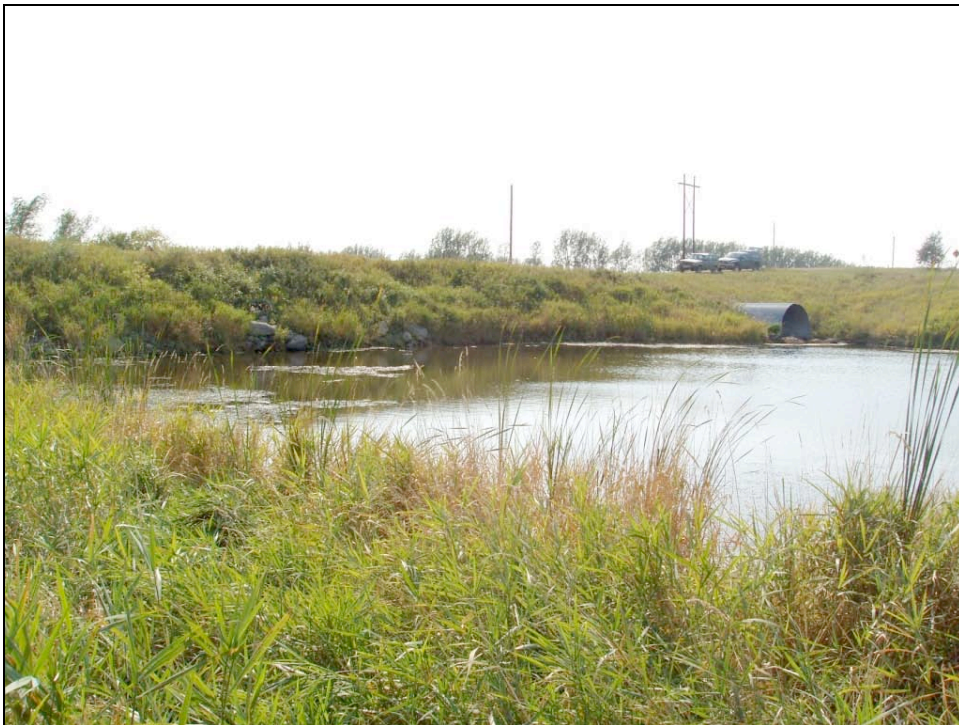
L16 Upstream side of four CMPs, the 120" is new & the three 48" are in poor condition, (120", 48", 48", & 48") 0.7 feet & no water in 48" CMPs (09-8-05), from west to east, Section 24, T156N, R69W, N 484269.36, E 2248476.13, elevation 1507.9 @ invert of 120" CMP, N 484237.96, E 2248440.55, elevation 1515.4 @ invert of 48" CMP, N 484242.19, E 2248581.31, elevation 1517.4 @ invert of 48" CMP, N 484240.98, E 2248596.95, elevation 1515.3 @ invert of 48" CMP.

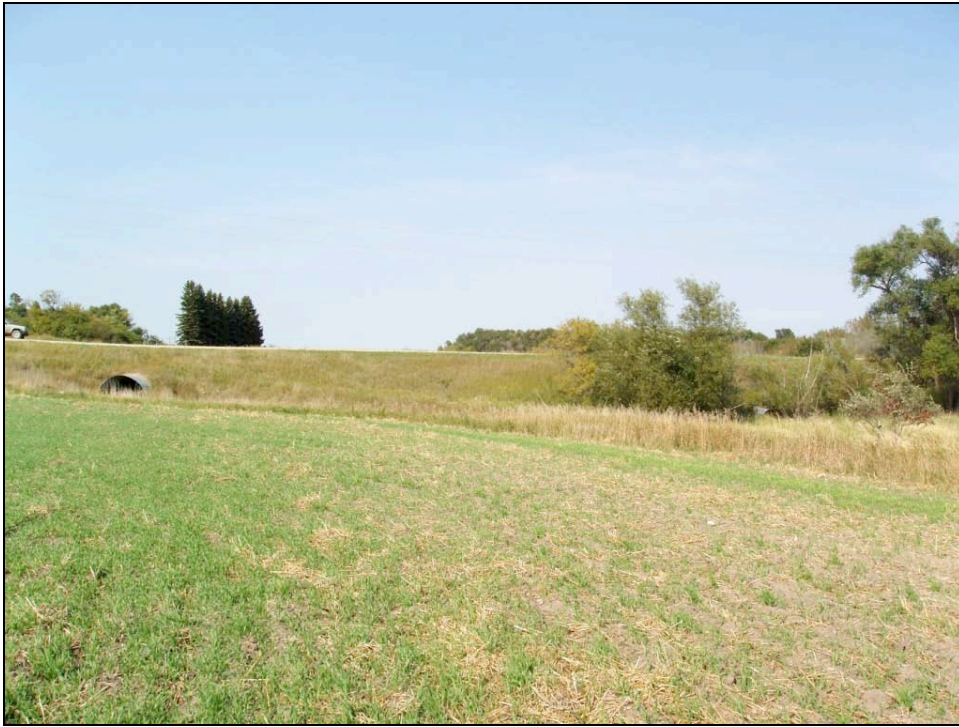
L16 Downstream side of four CMPs, the 120" is new & the three 48" are in poor condition, (120", 48", 48", & 48") 0.8 feet, & no water in the 48" CMPs (09-8-05), from west to east, Section 24, T156N, R69W, N 484150.79, E 2248461.99, elevation 1506.9 @ invert of 120" CMP, N 484155.24, E 2248557.99, elevation 1506.9 @ invert of 48" CMP, N 484156.92, E 2248580.59, elevation 1506.8 @ invert of 48" CMP, N 484158.22, E 2248602.94, elevation 1506.7 @ invert of 48" CMP.

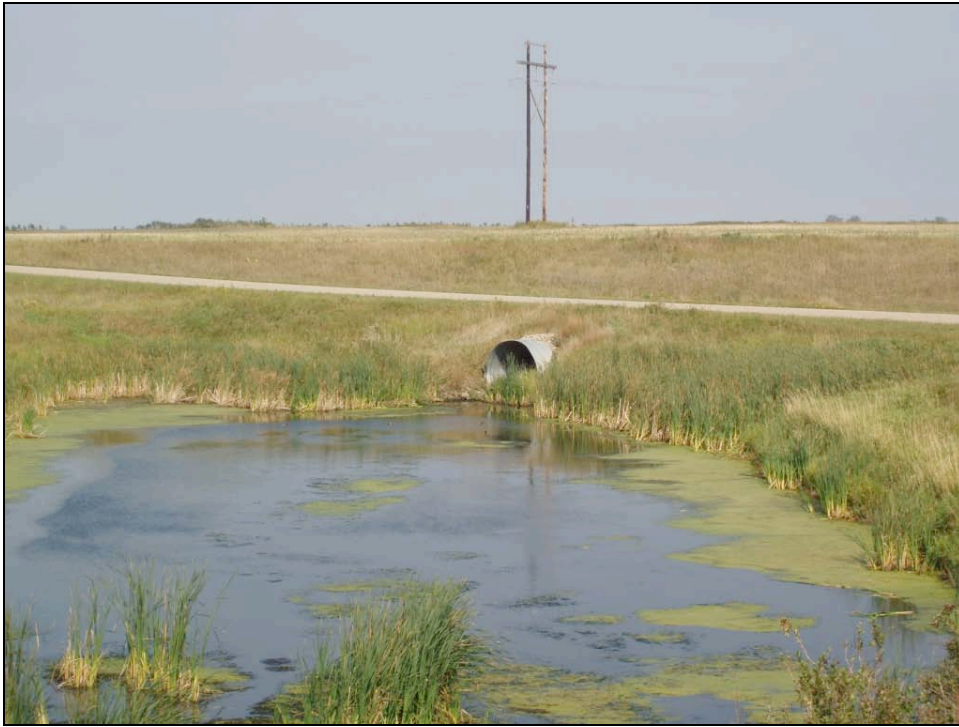
L17 Upstream side of one 108" CMP, in good condition, 0.6 feet of water (09-8-05), Section 14 & 13, T156N, R69W, N 486886.45, E 2247892.06, elevation 1513.1 @ invert of CMP.

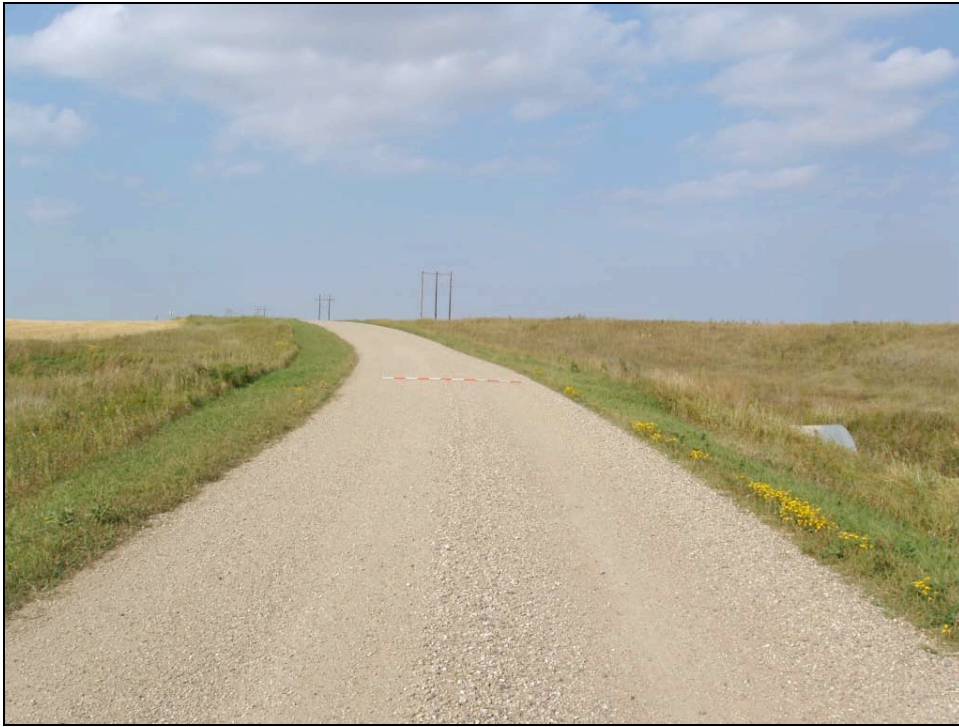
L17 Center of road crossing across one 108" CMP, looking north, Section 14 & 13, T156N, R69W, N 486875.52, E 2247935.23, elevation 1525.4 @ center of road crossing, across CMP, top of gravel.

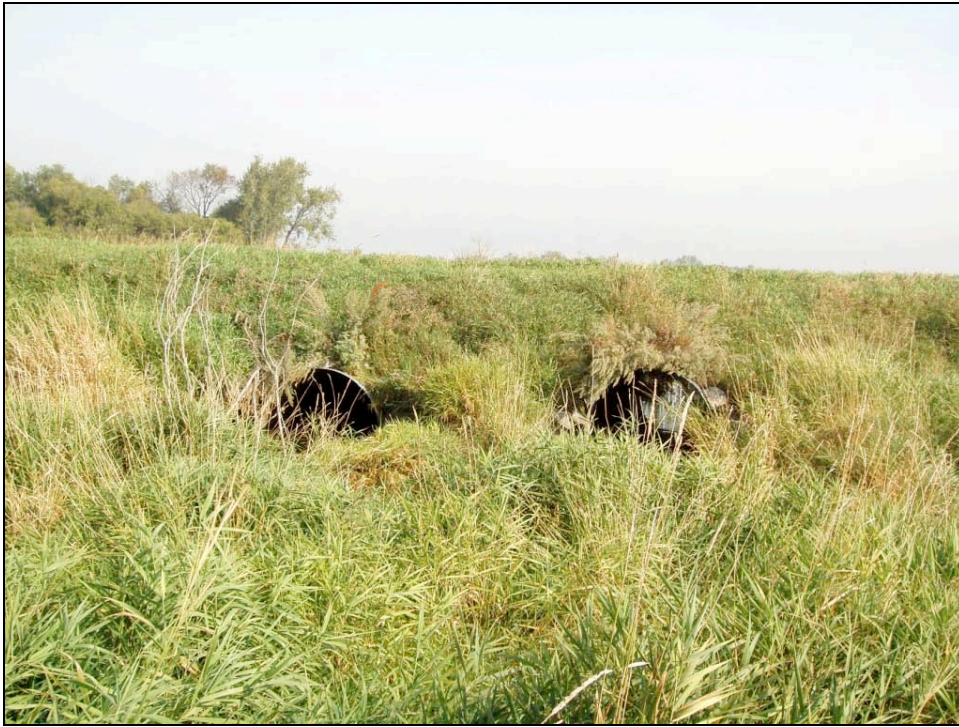
L18 Downstream side of two 72" CMPs, in good condition, 1.4 & 1.0 feet of water (09-9-05), east to west, Section 11 & 14, T156N, R69W, N 490254.99, E 2246935.95, elevation 1519.9 @ invert of 72" CMP, N 490255.55, E 2246920.53, elevation 1519.6 @ invert of 72" CMP.

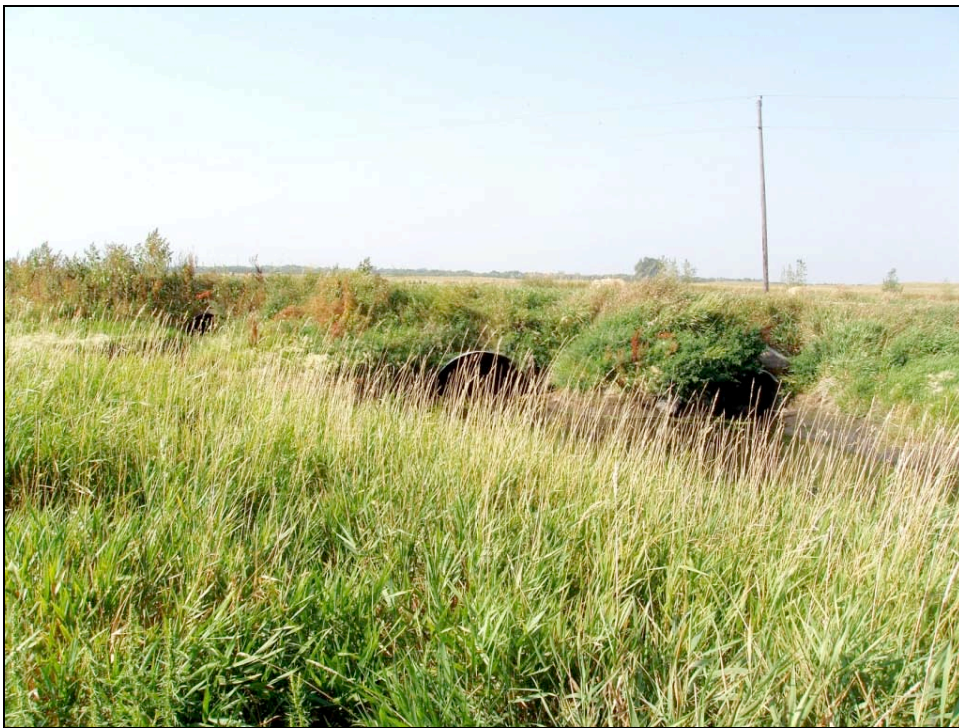
L20 Upstream side of three CMPs in good condition, (48", 60" & 48"),  
no water, 1.4 feet, & 0.9 feet of water (09-8-05) , from south to north,  
Section 2 & 1, T156N, R69W,  
N 499464.95, E 2247808.46, elevation 1529.3 @ invert of 48" CMP,  
N 499489.15, E 2247805.79, elevation 1526.9 @ invert of 60" CMP,  
N 499506.77, E 2247802.97, elevation 1527.6 @ invert of 48" CMP.

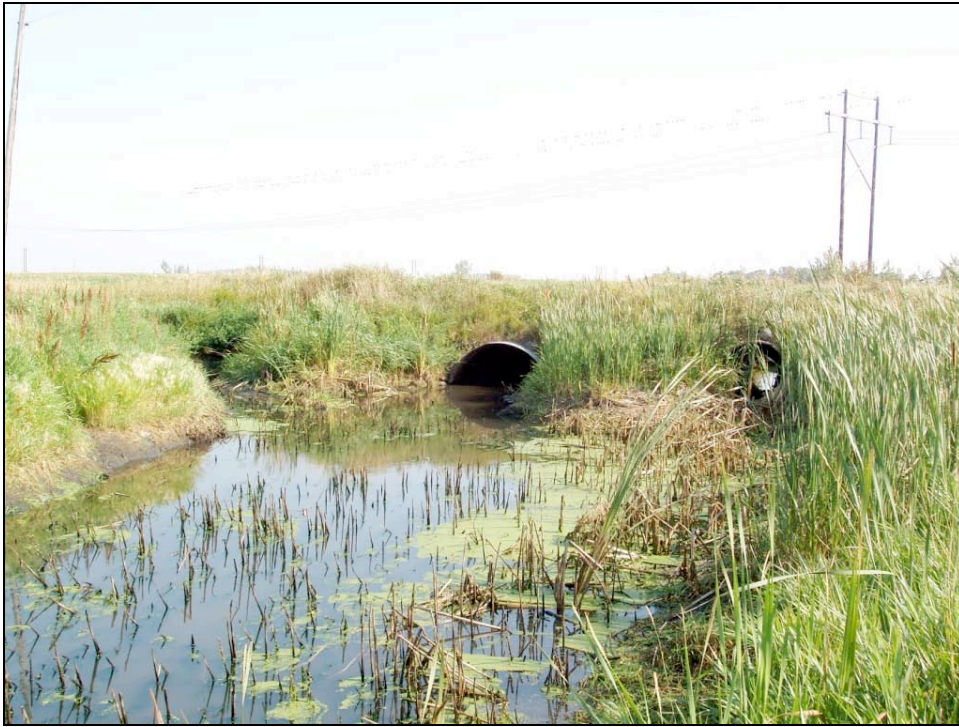
L20 Downstream side of three CMPs (48", 60" & 48"), in good condition, no water, 1.3 feet, & 1.2 feet of water (09-8-05) , from south to north, Section 2 & 1, T156N, R69W, N 499427.14, E 2247756.67, elevation 1528.9 @ invert of 48" CMP, N 499450.90, E 2247758.31, elevation 1527.1 @ invert of 60" CMP, N 499474.60, E 2247751.16, elevation 1527.9 @ invert of 48" CMP.

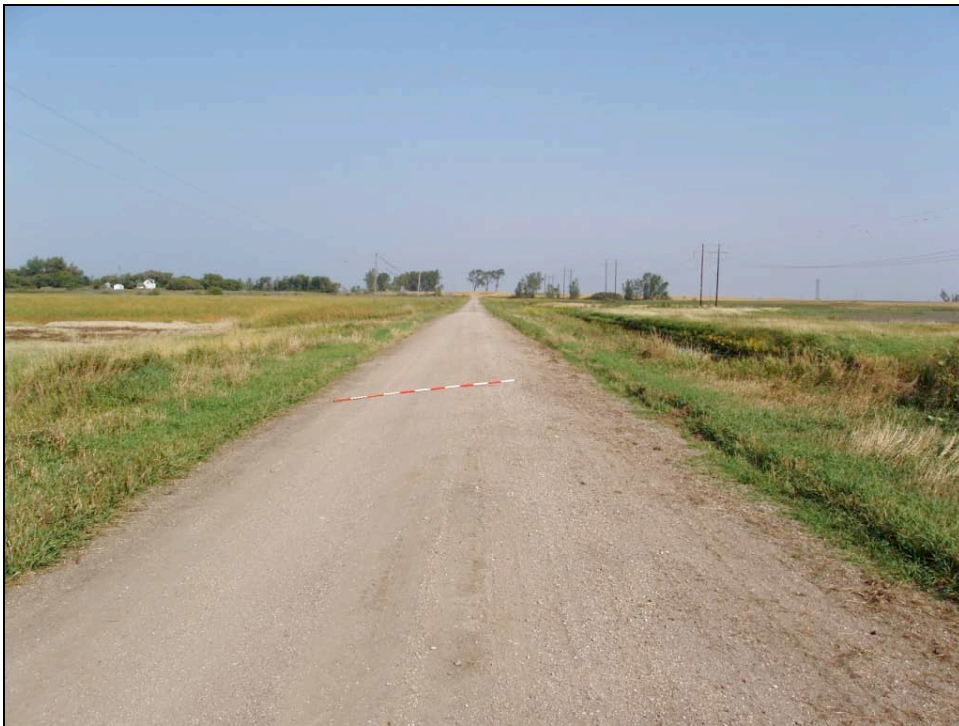
L20 Center of road crossing, across three CMPs, looking north, Section 2 & 1, T156N, R69W, N 499459.38, E 2247781.89, elevation 1535.6 @ center of road crossing, top of gravel.

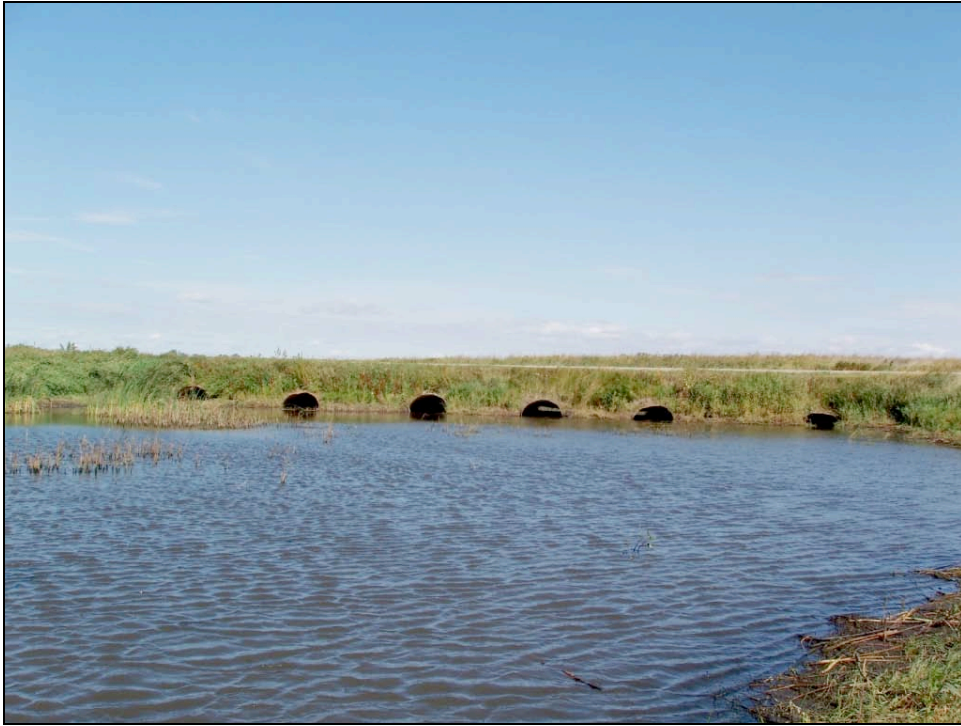
L23 Downstream side of six 48" CMPs in fair condition, 1.5 feet, 1.4 feet, 1.2 feet, 1.0 feet, 1.2 feet, & 1.0 feet of water (09-13-05), from east to west, Section 30 & 31, T157N, R68W,  
N 506982.63, E 2246574.56, elevation 1530.3 @ invert of 48" CMP,  
N 506980.37, E 2246553.14, elevation 1530.3 @ invert of 48" CMP,  
N 506979.71, E 2246537.76, elevation 1530.6 @ invert of 48" CMP,  
N 506979.09, E 2246522.43, elevation 1530.9 @ invert of 48" CMP,  
N 506977.85, E 2246504.14, elevation 1530.6 @ invert of 48" CMP,  
N 506976.94, E 2246488.25, elevation 1530.8 @ invert of 48" CMP.

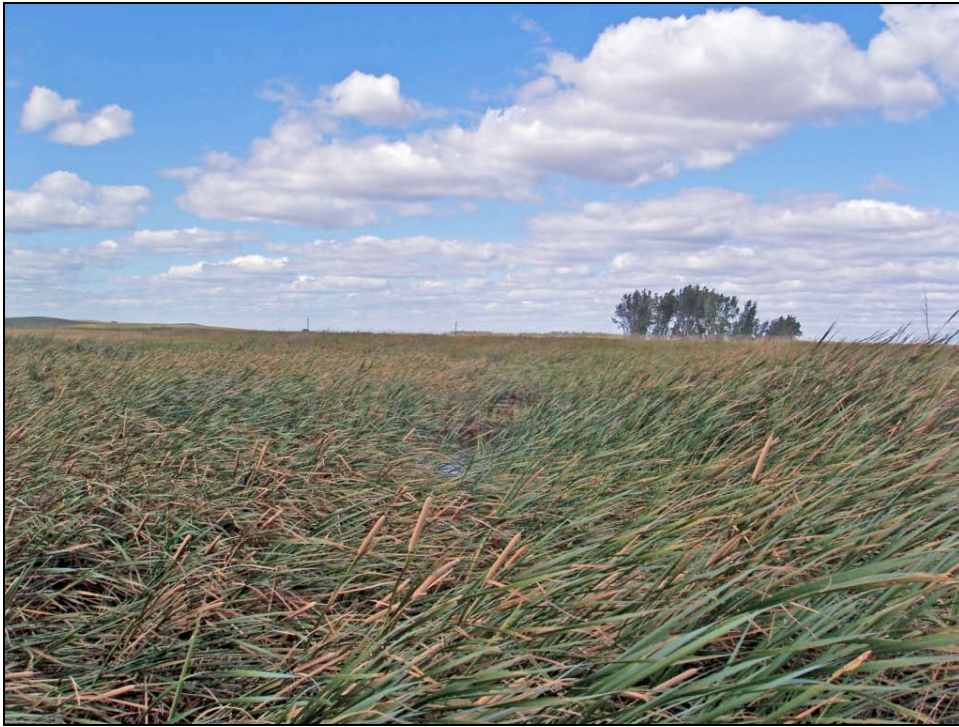
L24 Downstream side of four 60" CMPs in good condition, 1.8 feet, 1.2 feet, 0.9 feet, & 1.5 feet of water (09-13-05), from east to west, Section 23, T158N, R69W, N 546483.63, E 2236733.63, elevation 1534.6 @ invert of 60" CMP, N 546513.32, E 2236692.52, elevation 1536.1 @ invert of 60" CMP, N 546564.74, E 2236607.48, elevation 1536.5 @ invert of 60" CMP, N 546588.47, E 2236565.22, elevation 1535.9 @ invert of 60" CMP.

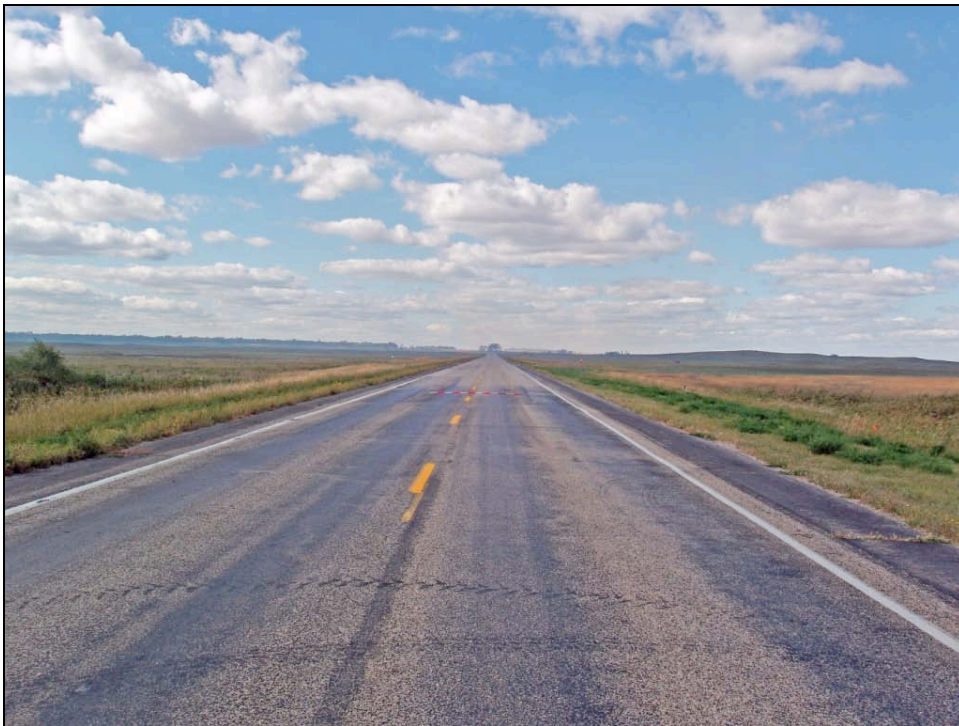
L24 Center of road crossing, across four 60" CMPs, looking west Section 23, T158N, R69W, N 546571.10, E 2236677.64, elevation 1544.7 @ center of road crossing @ Hwy 17, top of asphalt.

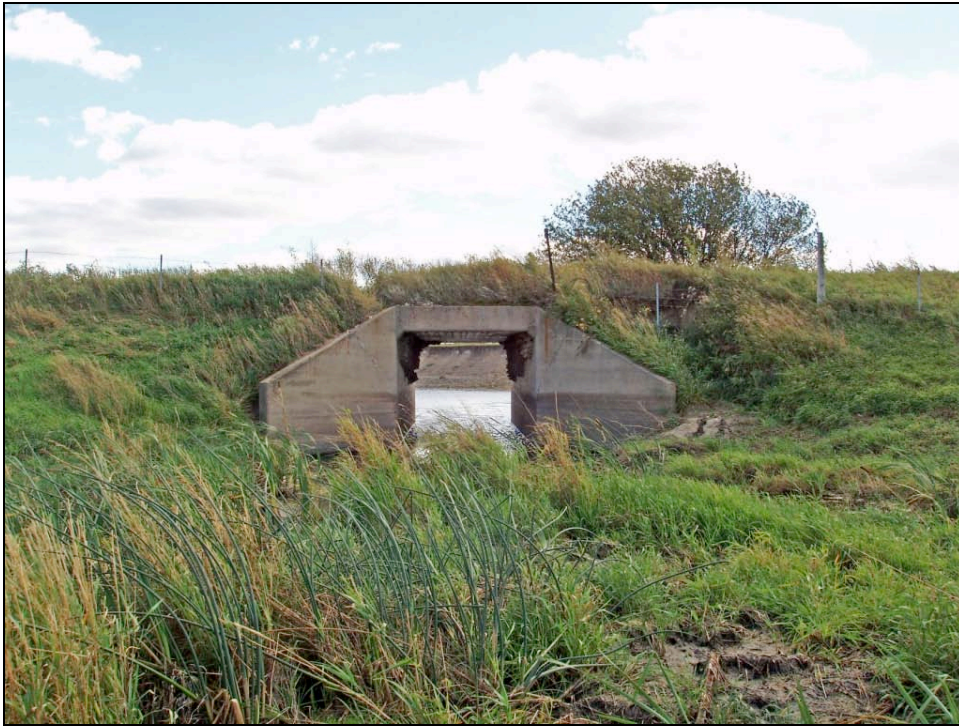
L25 Upstream side of single cell, 10 foot box culvert, in good condition, 1.6 feet of water (09-13-05), Section 14 & 23, T158N, R69W, N 549181.71, E 2235191.00, coulee bottom elevation 1536.3 @ C/L of box culvert.

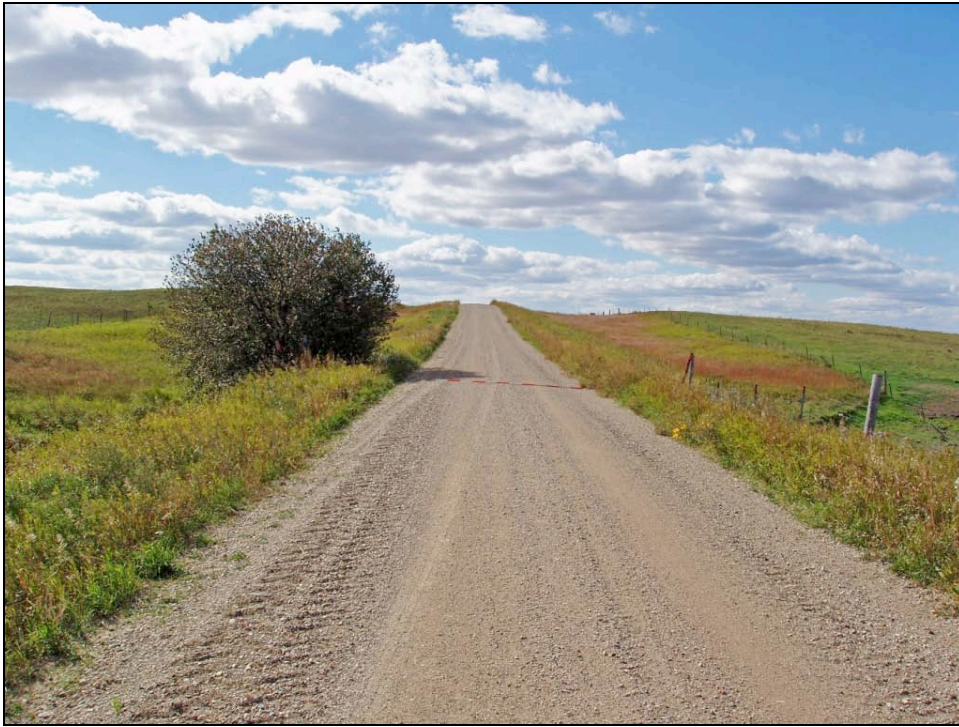
L25 Center of road crossing, 10.0 feet long box culvert, in good condition, looking west, Section 14 & 23, T158N, R69W, N 549166.16, E 2235191.83, elevation 1549.0 @ center of road crossing, top of gravel.

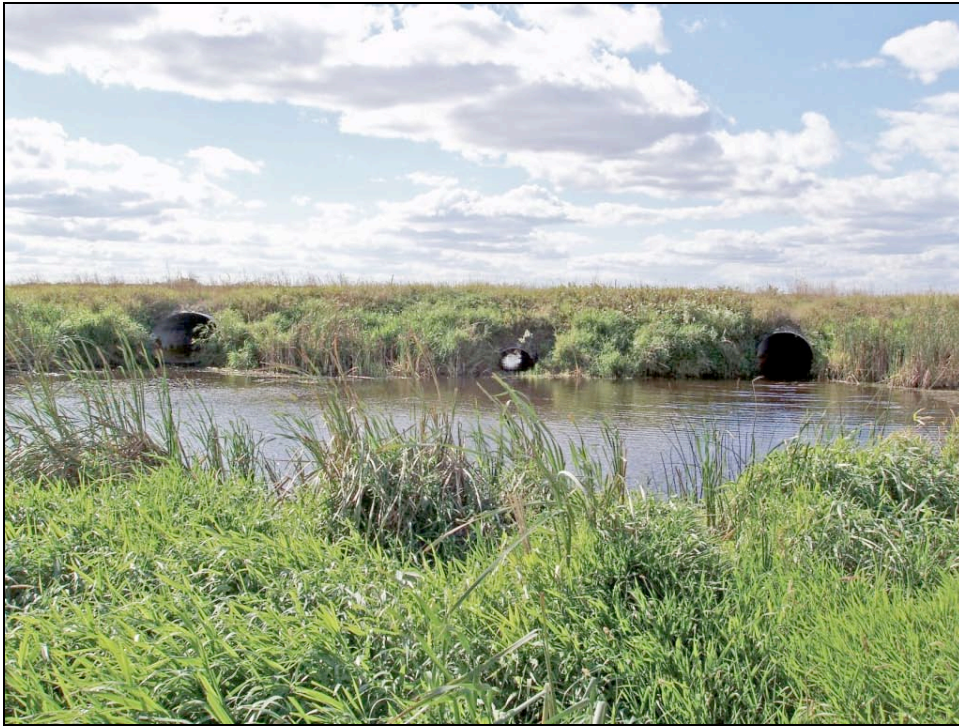
L26 Downstream side of three CMPs (60", 48" & 60") in good condition, no water, 1.5 feet, & 1.2 feet of water (09-13-05), from south to north, Section 15 & 14, T158N, R69W, N 553394.38, E 2233592.82, elevation 1542.4 @ invert of 60" CMP, N 553425.02, E 2233594.60, elevation 1540.9 @ invert of 48" CMP, N 553448.69, E 2233595.16, elevation 1541.1 @ invert of 60" CMP.

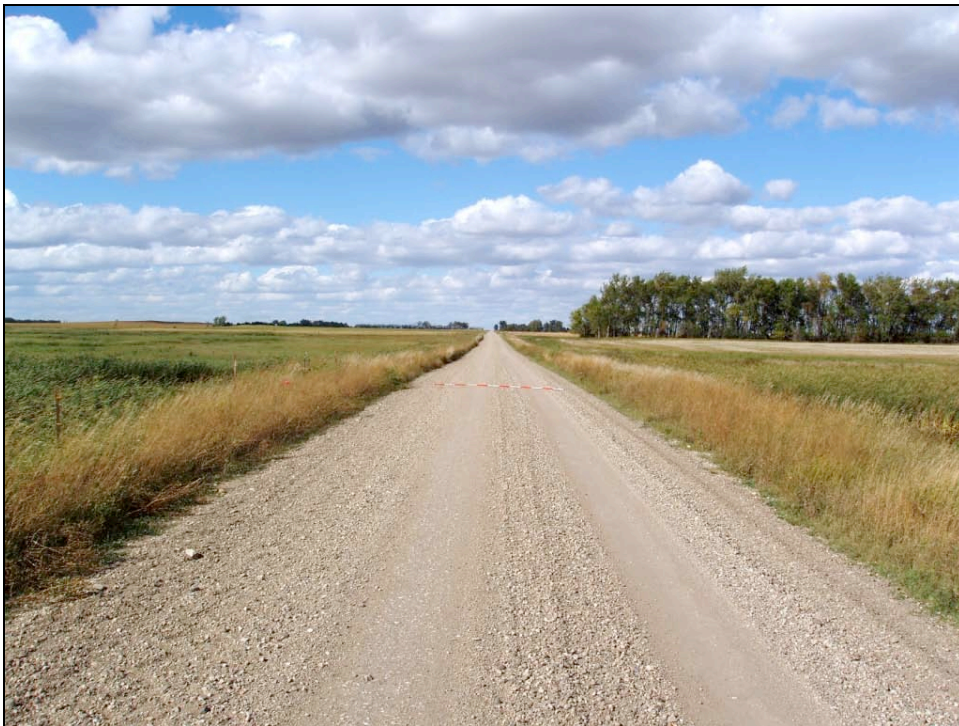
L26 Center of road crossing, across three CMPs, looking north, Section 15 & 14, T158N, R69W, N 553422.89, E 2233569.38, elevation 1549.0 @ center of road crossing, top of gravel.

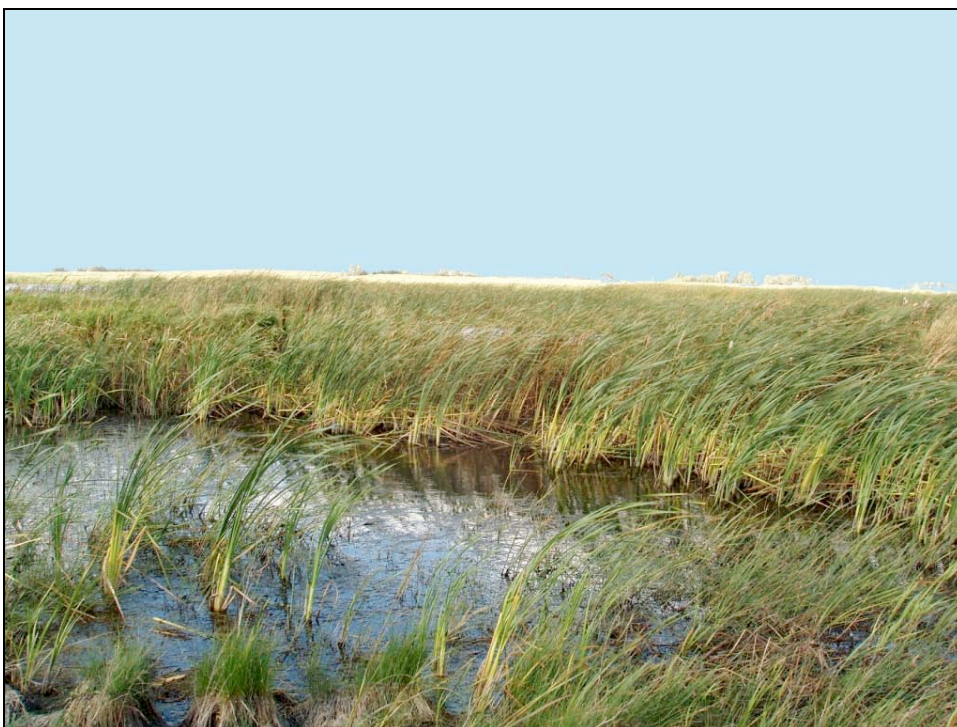
L27 Downstream side of Texas crossing, in poor condition, edge of water (09-13-05), Section 10 & 15, T158N, R69W, N 554413.03, E 2233120.56, elevation 1543.5 top of rocks.

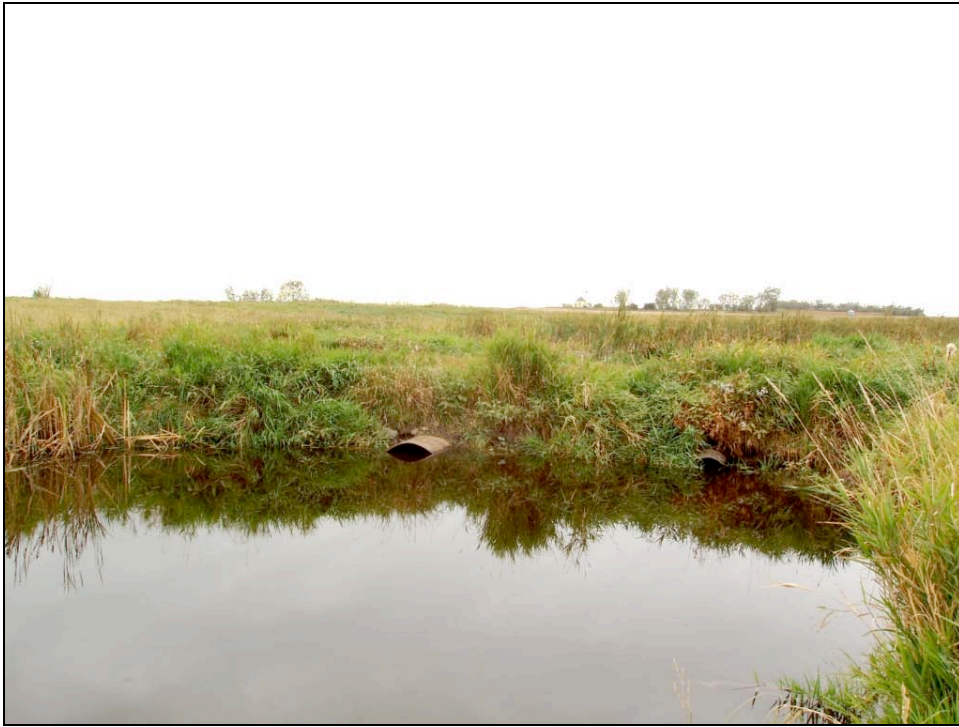
L30 Downstream side of two (48" & 24") CMPs, in fair condition, south to north, 3.7 feet, & 1.6 feet of water (09-14-05), Section 29 & 28, T159N, R69W, N 575114.97, E 2222762.49, elevation 1565.9 @ invert of 48" CMP, N 575128.70, E 2222763.50, elevation 1567.9 @ invert of 24" CMP.

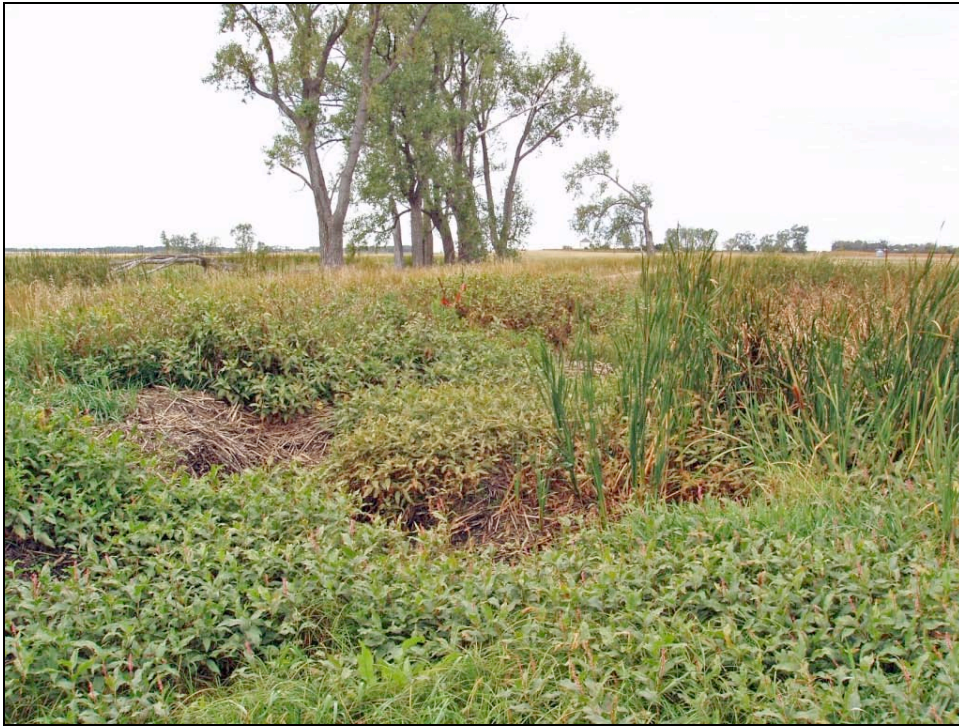
L31 Upstream side of three 36" CMPs, in good condition, east to west, 1.4 feet, 0.9 feet of water, & no water (09-14-05), Section 20 & 29, T159N, R69W, N 575461.01, E 2222511.21, elevation 1567.7 @ invert of 36" CMP, N 575464.36, E 2222485.28, elevation 1568.5 @ invert of 36" CMP, N 575460.50, E 2222434.11, elevation 1568.9 @ invert of 36" CMP.

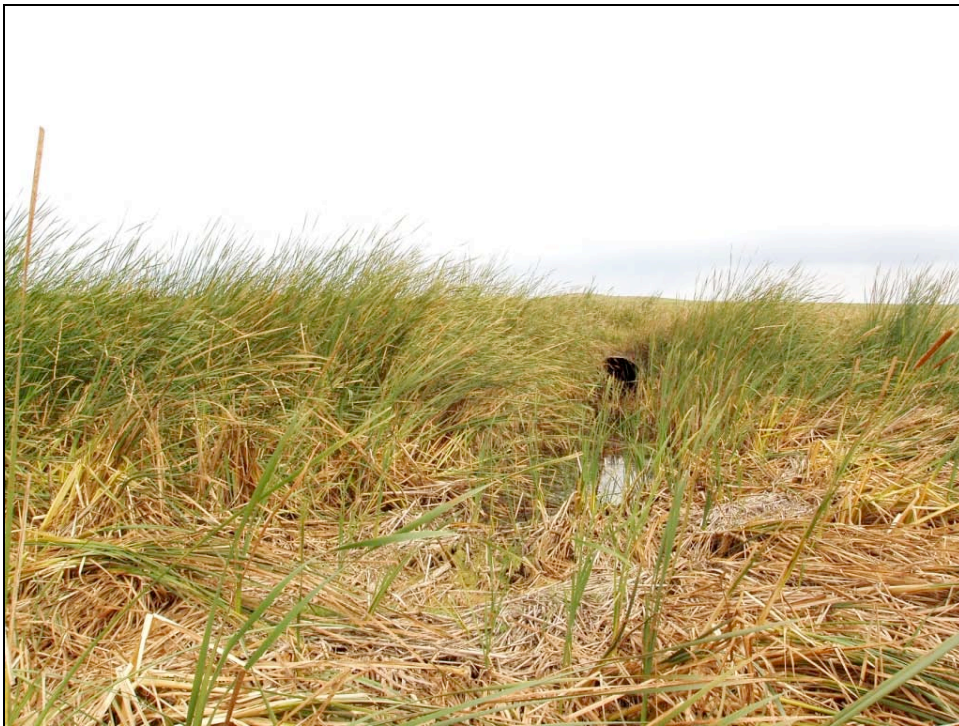
L31 Downstream side of three 36" CMPs, in good condition, east to west, 0.8 feet, 1.5 feet of water, & no water (09-14-05), Section 20 & 29, T159N, R69W, N 575429.30, E 2222510.78, elevation 1568.7 @ invert of 36" CMP, N 575419.56, E 2222481.05, elevation 1567.8 @ invert of 36" CMP, N 575419.97, E 2222439.52, elevation 1569.1 @ invert of 36" CMP.

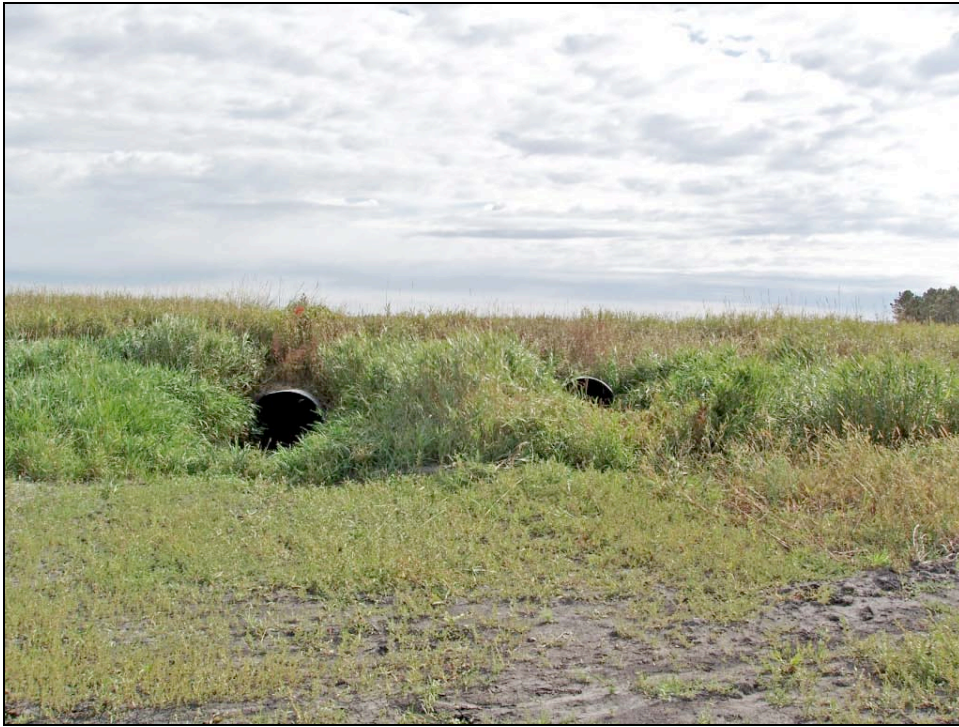
L33 Upstream side of two CMPs (36" & 48"), in good condition, south to north, no water & no water (09-14-05), Section 18 & 17, T159N, R69W, N 581507.09, E 2217352.77, elevation 1582.2 @ invert of 36" CMP, N 581521.94, E 2217352.44, elevation 1580.0 @ invert of 48" CMP.
